# Manhole Inspection Summary

Manhole # S21WW1030MH

Insp Date: **11/29/06 1:06 PM**

**Location** Address: **CROSS KEYS RD** Cross Street: **HAMLET HLL CT**

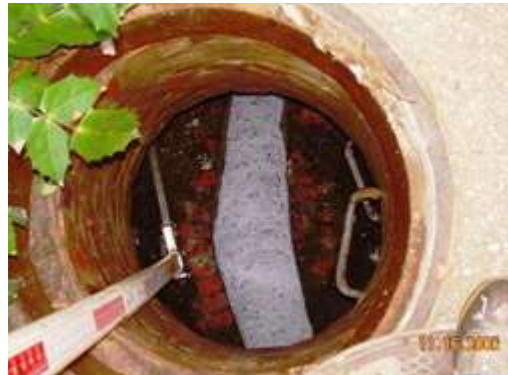
Top View

Frame offset. Adjustment deterioration and infiltration. Bench debris.

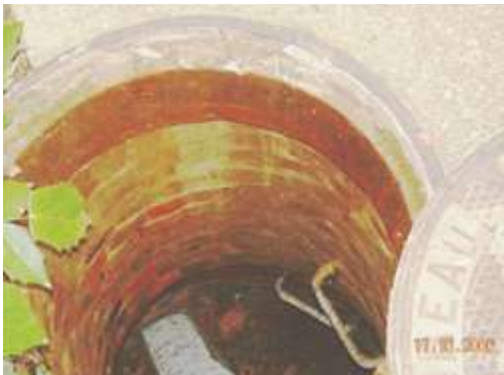
Defect

Frame leaks. Adjustment infiltration.

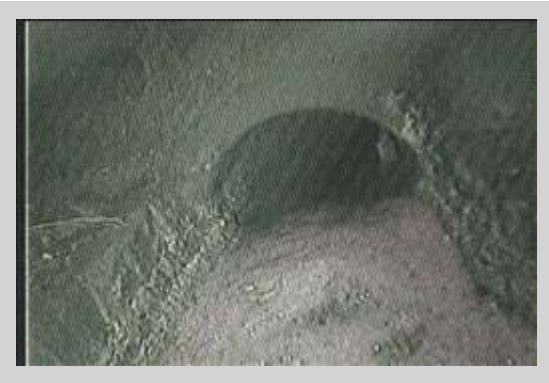
### 8 in. Circular Gravity Sewer Pipe Out @ 12 O'Clock

Deposits: ☐ None ☒ **Mud** ☐ Sludge ☒ **Debris** ☒ **Grease**

Silt Depth: **1.5** (in.) Deposits Extent: **Light**

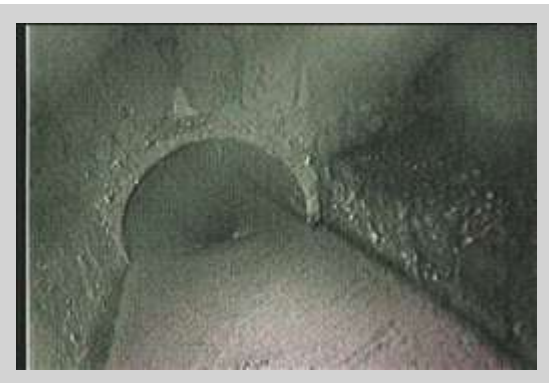
### 8 in. Circular Gravity Sewer Pipe In @ 5 O'Clock

Deposits: ☐ None ☒ **Mud** ☐ Sludge ☒ **Debris** ☐ Grease

Silt Depth: **1.5** (in.) Deposits Extent: **Light**
